**Historic Preservation Commission**  
**Agenda**  
**September 21, 2020**  
**6:30 pm**

**REQUEST:** The applicant requests to Landmark the structure at 633 La Farge Avenue and requests an Alteration Certificate allowing the relocation of the structure currently located at 1201 Lincoln Avenue to the southern portion of the lot.

# HISTORIC STRUCTURAL ASSESSMENT

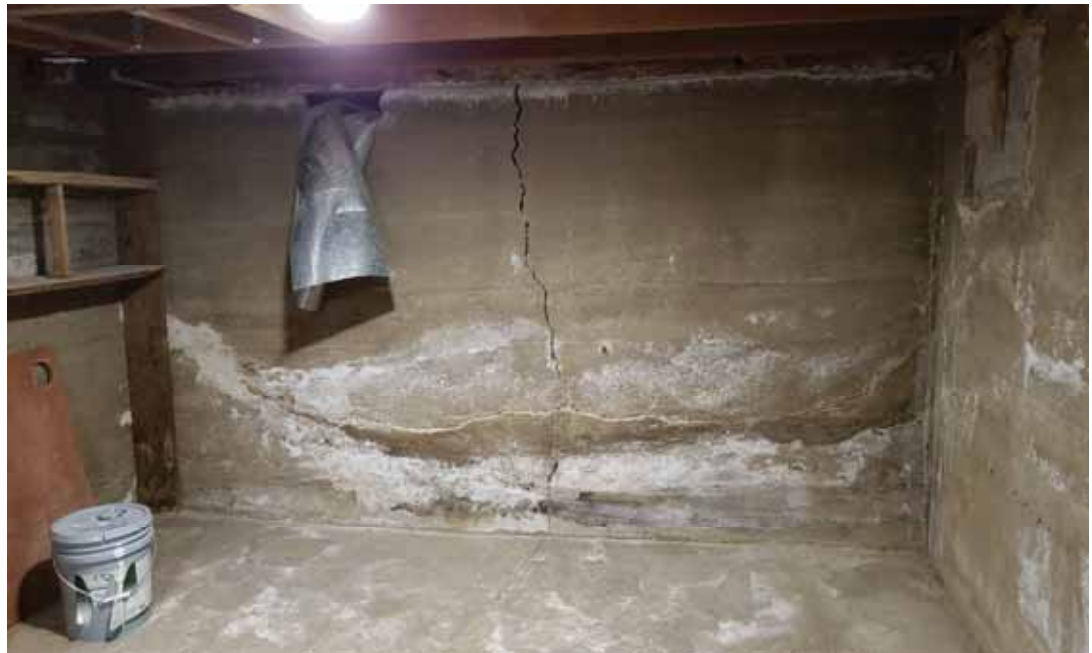
*Basement foundation wall with large cracks. Filled-in coal chute on the right and abandoned HVAC*

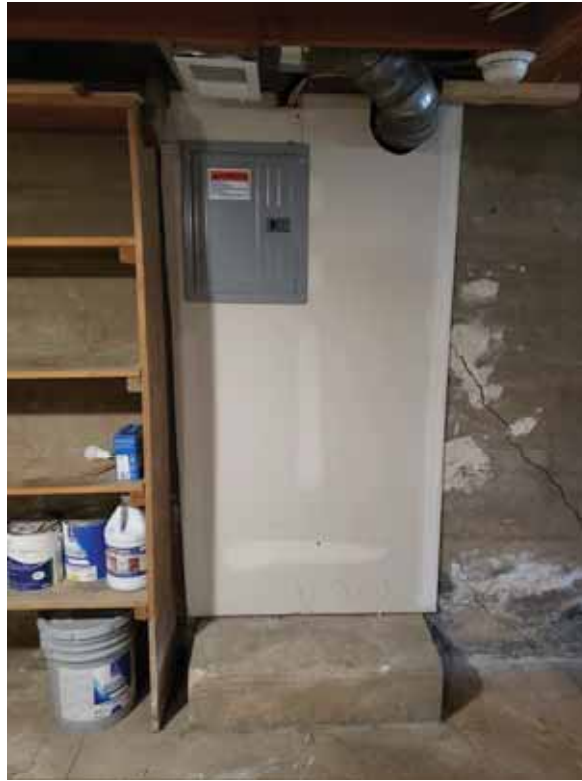
*Filled-in original stairs with large foundation crack on the right*

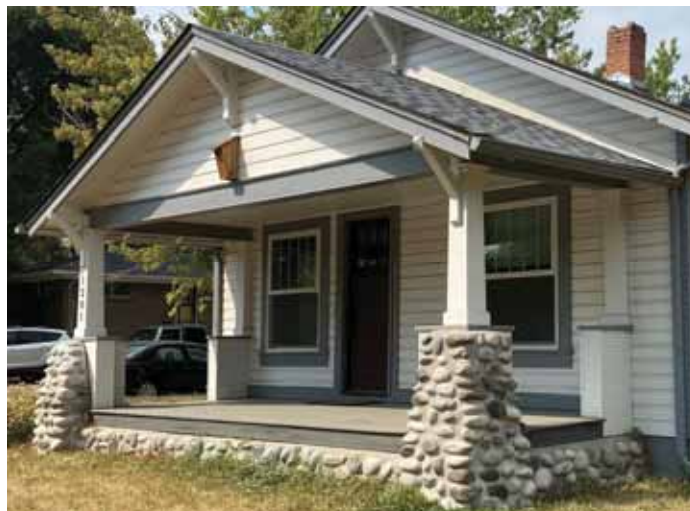
*Covered front porch*

1. Remove the river rock facing and bead-board siding on the front porch columns.
2. Rebuild the entire half-wall, leaving the opening on the south side.
3. Face the new half-wall with shake-shingle siding that flares at the base as seen in the 1948 photo. Several examples of covered porch half-walls with flared shake-shingle siding can be found in the Louisville area.

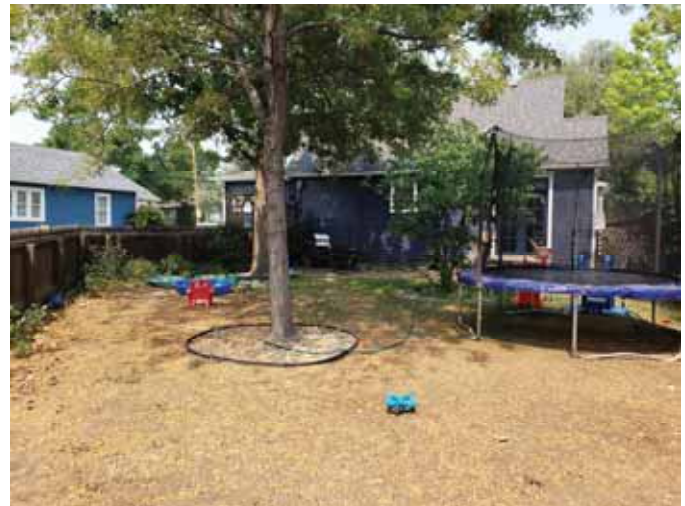
*Overall flat site*

1. Around the entire perimeter of the house, the finished grade should be a minimum of 6" below the top of the foundation and slope away from the foundation wall.
2. The drainage around the house should be maintained to be positive away from the house for at least the first 5 feet.
3. Consider re-grading the northeast corner of the lot, removing the retaining wall, and sloping the grade to drain towards the street curb and gutter.

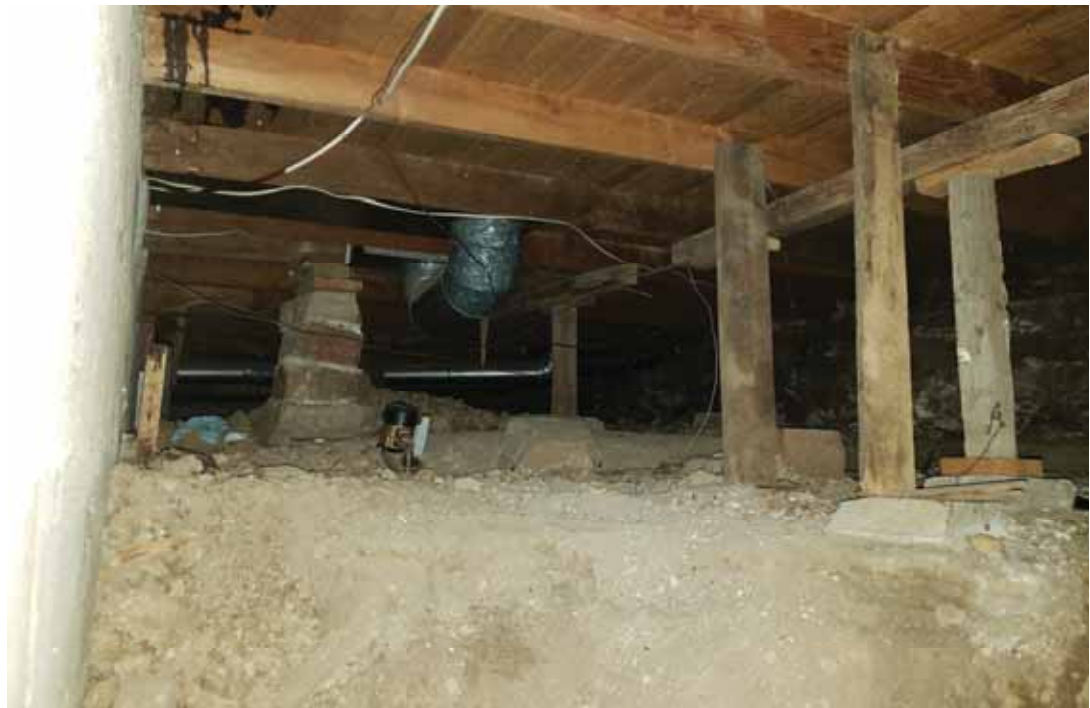
There is a stud wall between the crawlspace and basement that was coated with concrete that retains the crawlspace grade.

*Retaining wall (left), crawlspace & bearing posts, original stone foundation seen on the right*

1. Repair the crawlspace beam line and provide concrete foundation supports below each of the new and existing posts.
2. All exposed stone foundations should be repaired and repointed. The north foundation wall, towards the east end of the building, specifically needs repair.
3. Further investigation of the wood/concrete retaining wall between the crawlspace and the basement is needed. Likely, the studs should be replaced and/or properly anchored top and bottom.
4. The newer concrete walls below the original stone walls in the basement should be monitored and/or further investigated. Over time, the joint between the two types of foundation may result in water infiltration and movement. In addition, it is unclear if there is a proper footing below to help retain earth and prevent overturning.

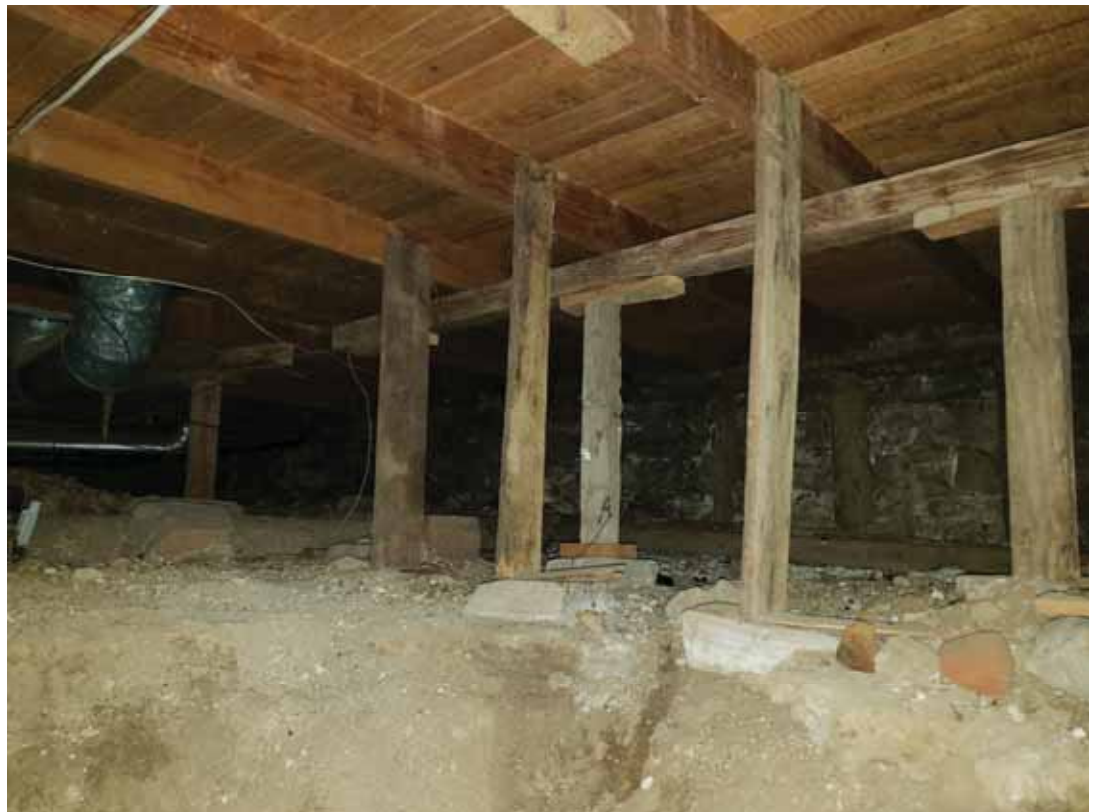
*Floor joist, floor sheathing (finished floor), & supports in crawlspace*

1. Add additional joists or interior supports to reduce the joist span and help reduce floor deflection.
2. Further review of the double plate being used as a bearing wall to support the main floor, upper floor, and roof framing. Either additional posts or a deeper beam system may be needed to properly support the loads above.
3. Further review, and possible replacement, of the beam and posts in the crawlspace may be required. See *Foundation Systems* section for further information about proper support of the wood posts.
4. Repair and replace the wall structure at the north foundation wall once the foundation issues have been properly addressed as discussed above.
5. Work with a licensed structural engineer to properly provide support of the floor framing around the stair opening to the basement. This will likely require a new structural beam and support of interrupted floor joists.

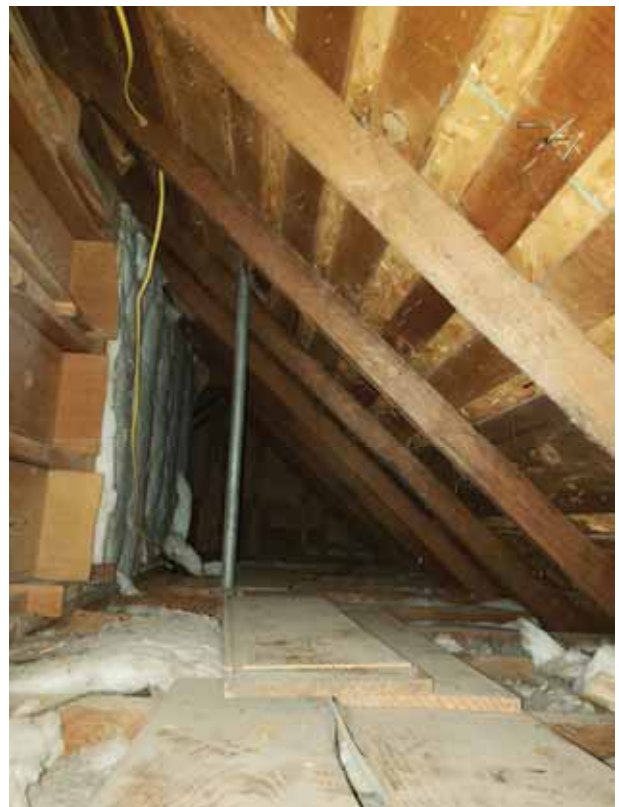
*Roof framing inside attic space*

1. Add additional ceiling members or intermediate ceiling beams to reduce ceiling joist spans. The 2x4 cripple walls add additional load to an already over-stressed ceiling system.
2. Investigate the roof framing in the west addition and front porch to determine if they need additional support.

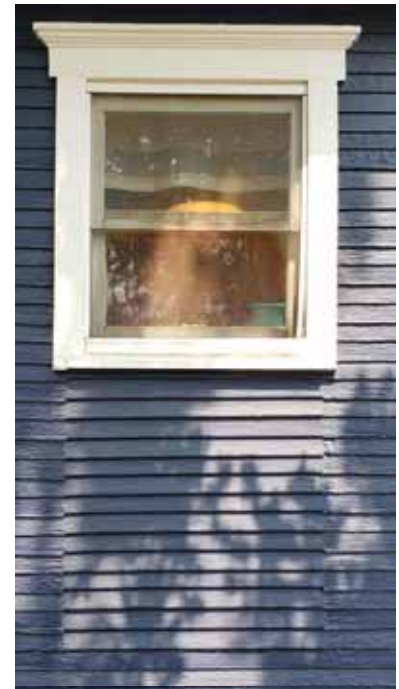
*Original window size seen in siding patch*

1. Replace all windows with new, operable windows that match the styles currently found. The glider windows may or may not be original to these locations. Clues as to the original window sizes may still exist in the framing. If the framing is exposed for repairs in the future, consider replacing these windows with windows matching the style found in the northwest corner of the west addition.
2. Replace the French door on the south side with a tall and narrow window, as found on the remainder of the original house.
3. Replace the window in the bathroom with a taller, single-hung window, as seen in the siding patch, with a window that matches those found on the remainder of the house.

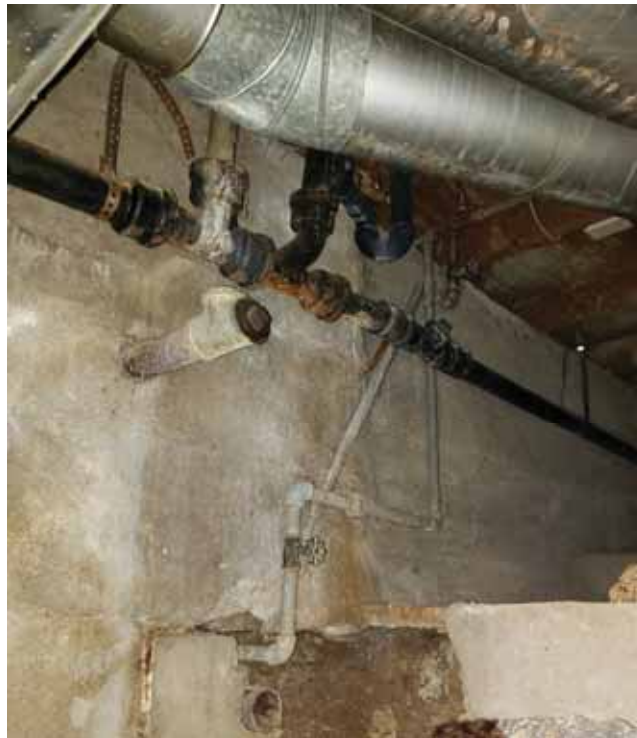
*Plumbing distribution & waste lines - some appear to be abandoned*

1. Work with a licensed plumber to remove all galvanized piping, those that are still in use and those that are abandoned, and run new distribution lines, either copper or PEX to all plumbing fixtures.
2. Work with a licensed plumber to remove and replace any deteriorated cast-iron waste lines and any ABS lines that show signs of deterioration.

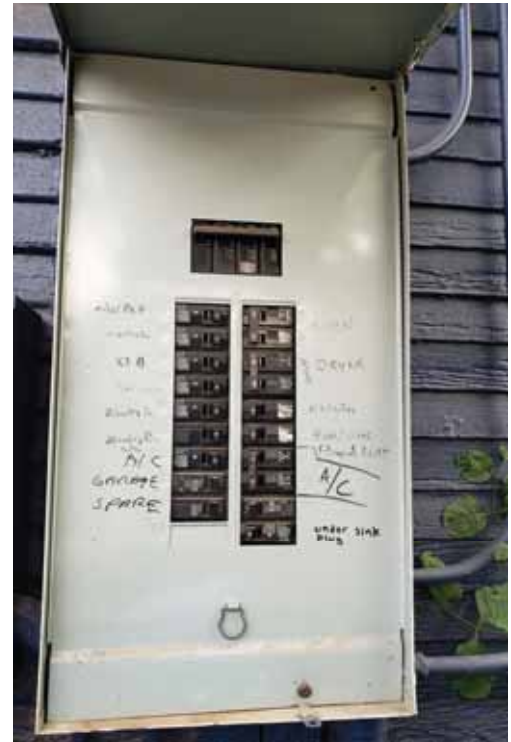
*Main electric panel*

1. Replace any remaining knob & tube wiring with new Romex wiring.
2. Consider updating to a 200-amp panel.
